# Manhole Inspection Summary

Manhole # S31CC2011MH

Insp Date: **12/5/06 2:58 PM**

**Location** Address: **115 CHURCHWARDENS RD**

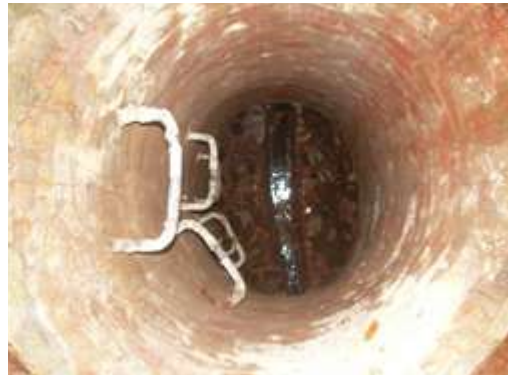
Top View

Bench and Channel debris.

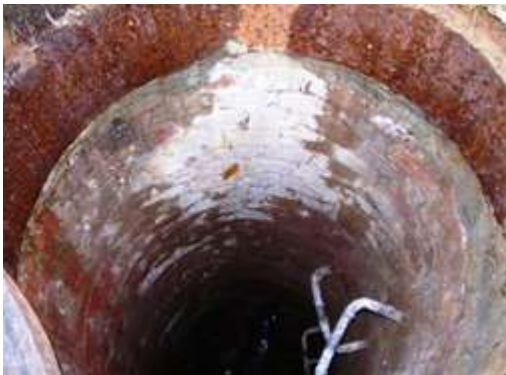
Defect

Adjustment deterioration and infiltration.  
Corbel and Barrel infiltration.

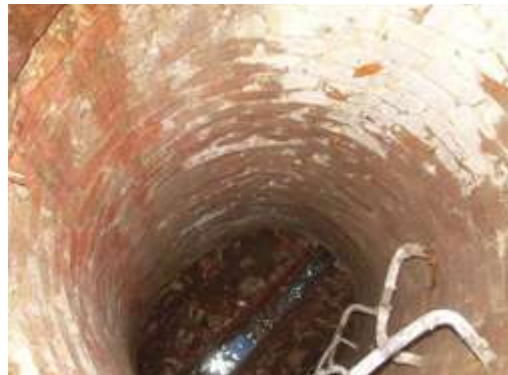
Defect

Adjustment deterioration and infiltration.  
Corbel and Barrel infiltration - other side.

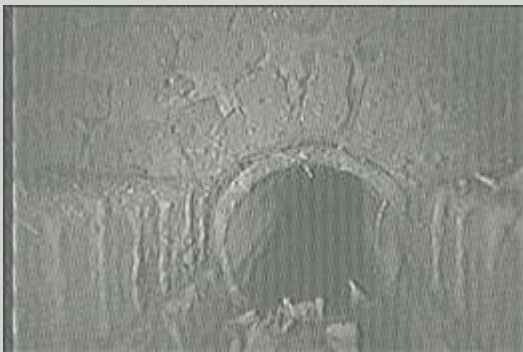
### 8 in. Circular Gravity Sewer Pipe Out @ 12 O'Clock

Deposits: ☐ None ☐ Mud ☐ Sludge ☒ Debris ☒ Grease

Silt Depth: **0** (in.) Deposits Extent: **Light**

Infiltration: **Evidence** Pipe Seal Cond: **Roots**

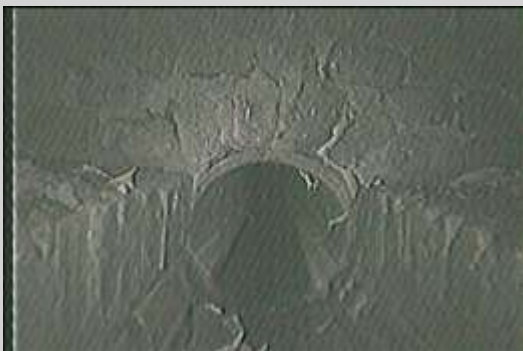
### 8 in. Circular Gravity Sewer Pipe In @ 5 O'Clock

Infiltration: **Evidence** Pipe Seal Cond: **Unknown**
